All-domain Anomaly Resolution Office

Case: "Atmospheric Wakes"

Case Resolution | 8 May 2023

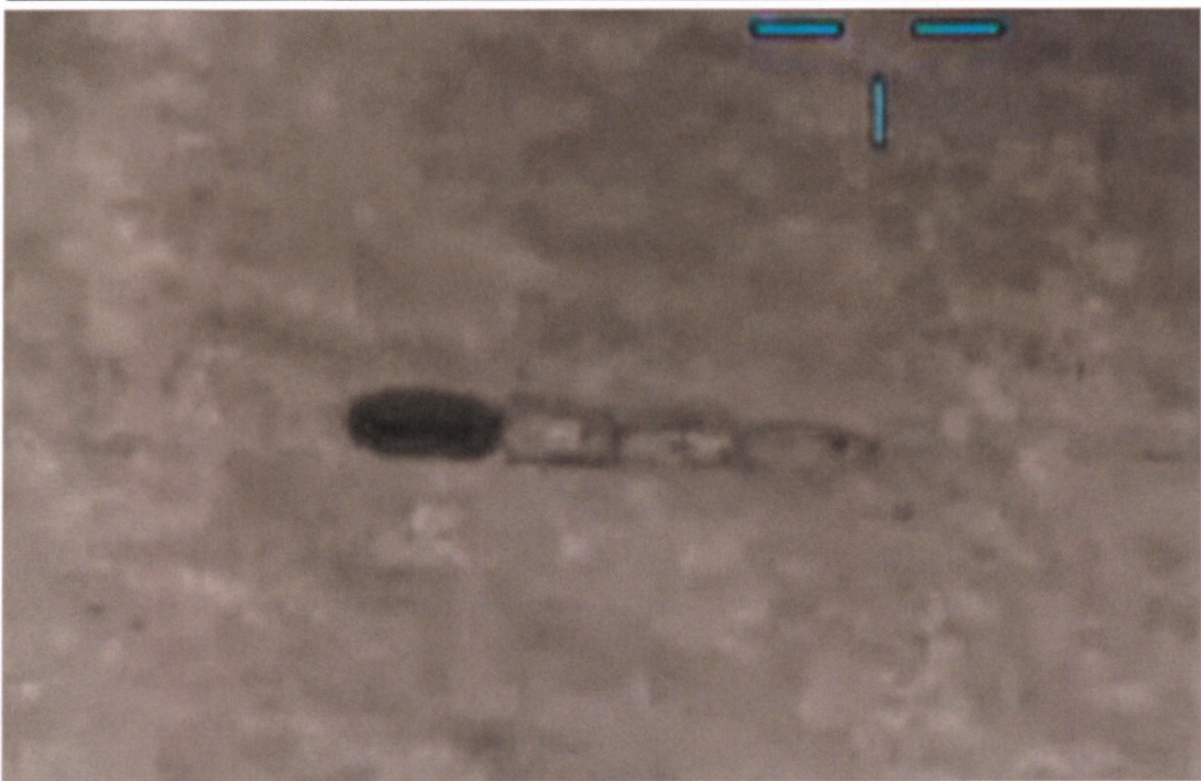
"Atmospheric Wakes" Case Two: Sensor Artifact Trailing the Aircraft

(U) For the two UAP reported in Case Two, it is assessed that both objects are most likely aircraft, one military and the other a small but unidentified aircraft. Location data from aircraft in the vicinity were compared and it was determined that one of the UAP matched closely with a track of a military aircraft.

- (U) Although a similar match of the second object was not possible, it was assessed with medium confidence that it was a small aircraft. This assessment was based on line of sight analysis and comparing it to other known objects.

- (U) S&T Partner One assessed the trails were camera artifacts resulting from the object rapidly traversing the camera's field of view. It was noted that other objects in the videos also leave a similar trail.
- (U) S&T Partner Two conducted a detailed analysis of the full-motion video and the IR sensor, reaching the same high confidence conclusion that the wakes were sensor artifacts.

(U) Case Two: Sensor artifact trailing the aircraft.
